SOIL CONSERVATION

VOL. III • NO. 12

JUNE • 1938

ISSUED MONTHLY BY THE SOIL CONSERVATION SERVICE, DEPARTMENT OF AGRICULTURE, WASHINGTON

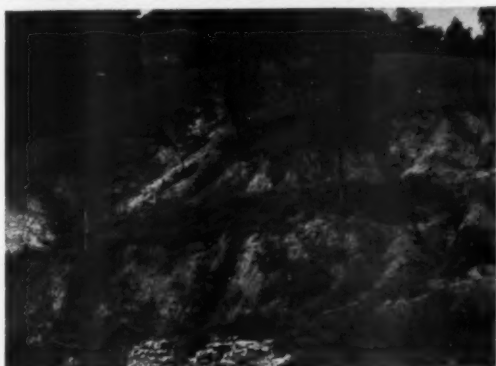
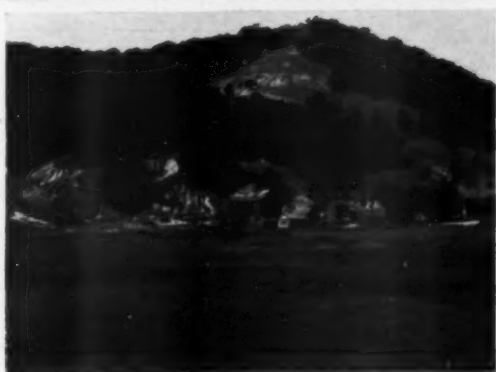
Can this be the same place? Yes, and part of the family still lives here. The glass is missing from many windows. The rock wall is buried in sand and silt. The old road is under 4 feet of washed-down deposits. The porch, once lattice-ornamented, looks lower, doesn't it? Even the trees are dying.

Here on this soil-robbed hillside is the close-up fingerprint of guilt. Ruthless erosion has left its undisputed mark.

Below the close-up is a more distant view of broken slopes and overgrazed pastures—appropriate background for dilapidated farm buildings which once set the local high standard.

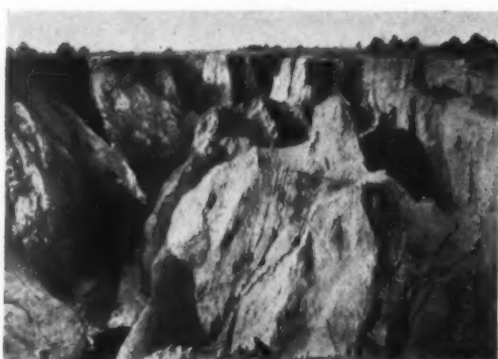
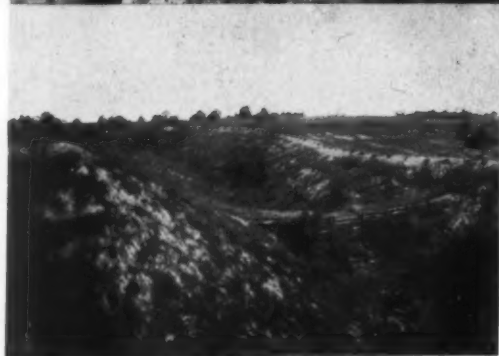
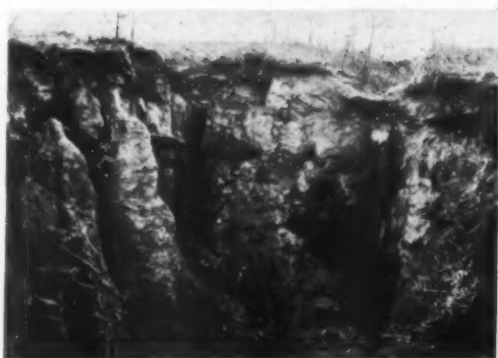
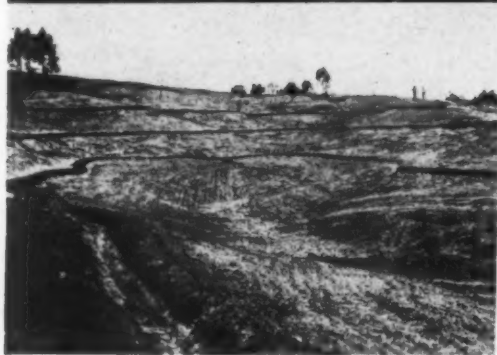
Almost unbelievable is the magic wrought by bulldozer blade, black-locust plantings, lespedezas, and small grain on gnawing gullies in South Carolina. The camera does not lie, and the completeness of the transformation is attested in these "before and after" scenes of the Berry gully near Spartanburg, S. C.—one of the first jobs of the kind completed on the South Tyger River project. From this gully each week over a period of 8 years was washed the equivalent of three 32-ton carloads of material. The gully drained less than 5 acres and was extending at a rate of 100 feet a year. When work began in 1933 it had ruined 40 acres of good bottom land.

Again, the wand of bulldozer, small grain, black locust, contour terraces, a diversion ditch at the head, and Bermuda sod on the terrace ridges. This stablization job pertains to a gully on the C. D. Entrekin farm near Switzer, S. C.

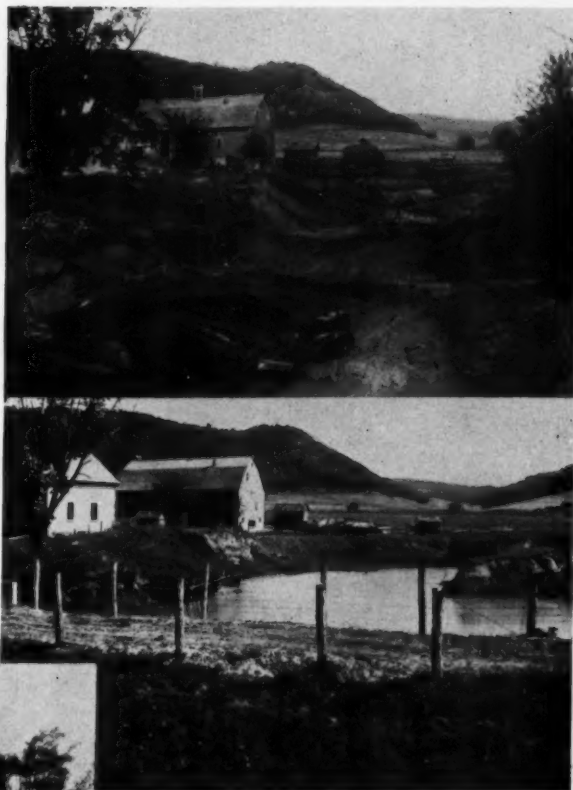
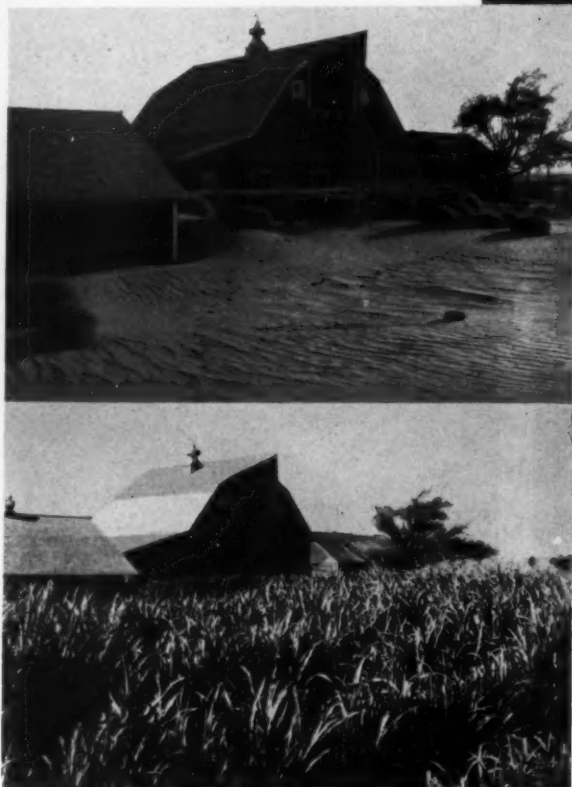
Right: A house and barn in Buffalo County, Wis., threatened with engulfment by a gully. Today they are protected by piling-bulkhead and rock-brush deflecting dams. Note the adequate fencing, the roadway atop the fill, the useful farm pond.

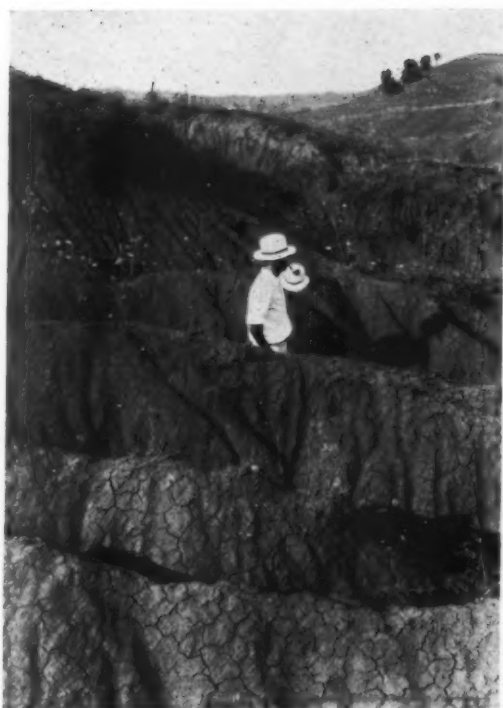
Gone here, near Spencer, W. Va., not only the vegetation but the organic matter and a lot of the subsoil. The soil moves down so fast during a gully washer that few plants dare try to cover the surface.

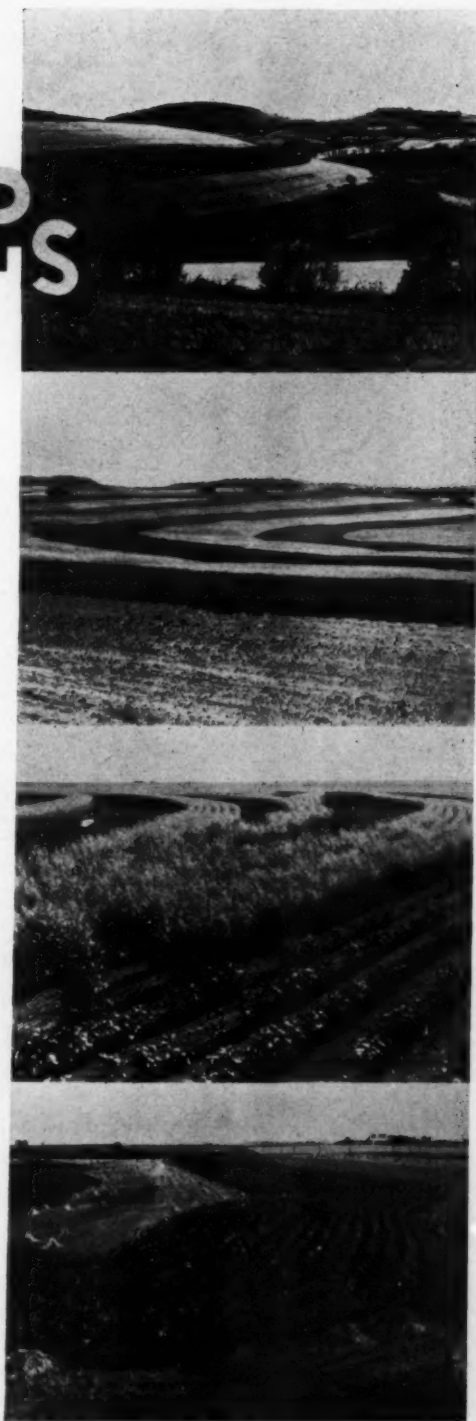
Contour strip cropping is a practice that was picked up from farmers in Wisconsin, New York, Pennsylvania, Ohio, and West Virginia who are farming rolling land and fairly steep hillsides. On some farms, a modified form of strip cropping has been carried on for many years.

Contour strip cropping is a practical method of farming on erosive slopes with a minimum loss of soil. It is merely a field arrangement and can in no way substitute for the use of proper crop rotation. In fact, an excellent strip cropping system embodies the best crop rotations. The rotations can be worked out by strips or by fields so that wheat stubble and hay aftermath can be grazed. Strip cropping is readily adapted for the livestock farm. For cash crop areas, it leads toward diversification, which is so essential to a truly permanent agriculture.

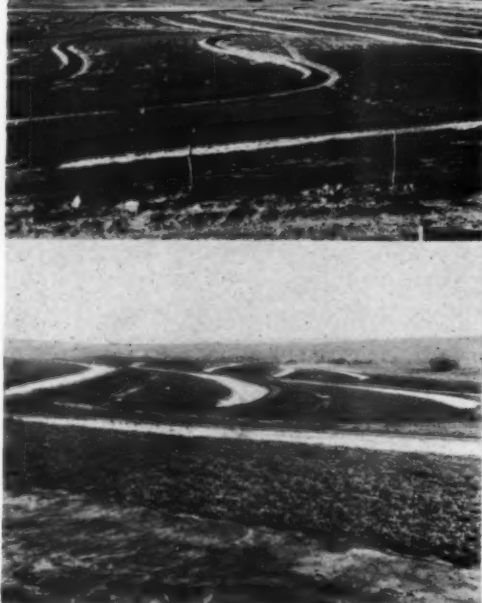
The development of terracing as recommended today has required years of use, extensive field observations and experimentations, and many modifications from time to time in construction procedure. When terraces are properly used and constructed and adequately supported by approved cropping and tillage practices they provide one of the most effective erosion control measures applicable to cultivated lands. When improperly constructed or not coordinated with proper land-use practices they often accelerate rather than retard soil losses.

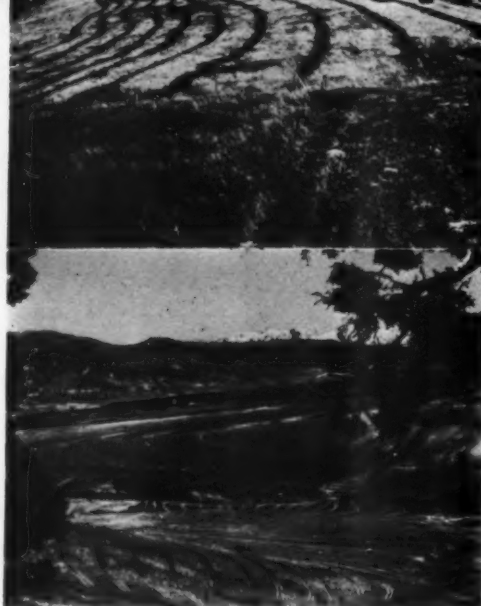
Contour furrows are small and constructed on the contour. In humid areas their primary function is soil conservation, while in areas of low rainfall it is conservation and distribution of moisture that would otherwise be

lost. The amount of water they can retain depends upon their water cross-section area, their spacing, and the absorption characteristics of the soil. To obtain uniform distribution of moisture, spacing should seldom exceed 10 feet.

Most contour furrows have been made by moldboard plows, listers, graders, and subsoilers. The most satisfactory ones are obtained by low cost machines, which do the work without destroying existing turf. Several attempts have been made to develop special machines for the purpose.

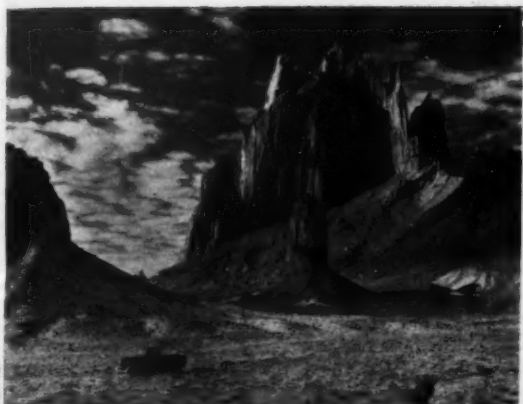
Shiprock, N. Mex.—Geological erosion above, accelerated erosion around base.

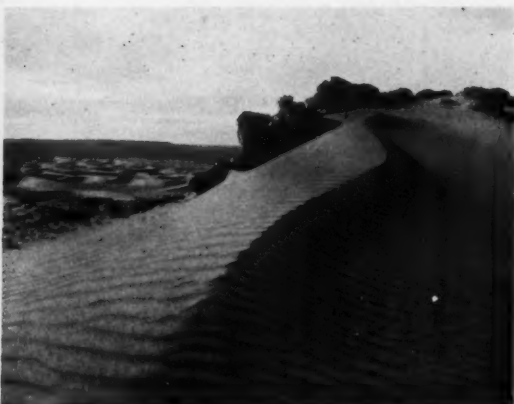
Sand dunes at Laguna, Valencia County, N. Mex. The accumulation of sand is on the east slope of the ridge; the main dunes may be seen in the background.

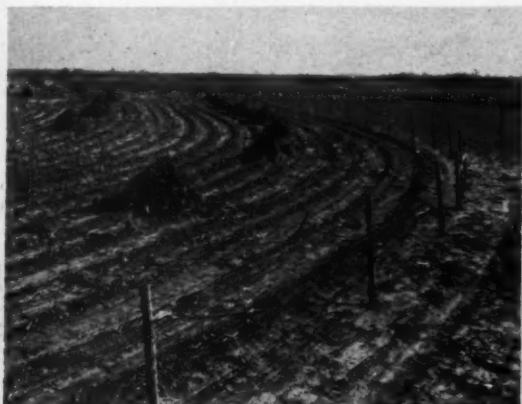
An excellent example of contour fencing in the west. This device is of proved advantage in farming for soil conservation.

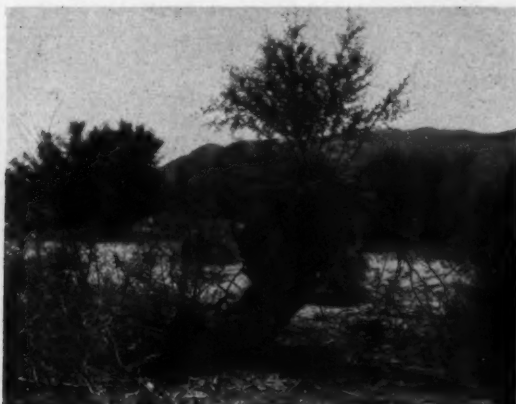
An old mesquite stump in Arizona, sprouting several years after being cut.
